Blade Deflection Measurements of a Full-Scale UH-60A Rotor System

Blade deflection (BD) measurements using stereo photogrammetry have been made during the individual blade control (IBC) testing of a UH-60A 4-bladed rotor system in the 40- by 80-foot test section of the National Full-Scale Aerodynamic Complex (NFAC). Measurements were made in quadrants one and two, encompassing advance ratios from 0.15 to 0.40, thrust coefficient/solidities from 0.05 to 0.12 and rotor-system drive shaft angles from 0.0 to -9.6 deg. The experiment represents a significant step toward providing benchmark databases to be utilized by theoreticians in the development and validation of rotorcraft prediction techniques. In addition to describing the stereo measurement technique and reporting on preliminary measurements made to date, the intent of this paper is to encourage feedback from the rotorcraft community concerning continued analysis of acquired data and to solicit suggestions for improved test technique and areas of emphasis for measurements in the upcoming UH-60A Airloads test at the NFAC.

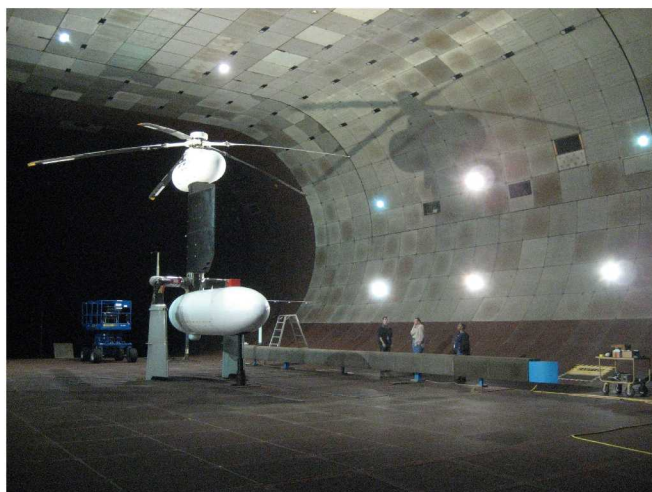
Figure 1. Boeing/DARPA SMART Rotor Test in NFAC.

detailed experimental measurements obtained under conditions representative of actual flight conditions. High-quality rotor blade deflection data sets are relatively rare. In 2001, photogrammetric mappings of blade deflections were obtained during the HART II rotor test at the German-Dutch Wind Tunnel (DNW) as described in reference 2. Recently, blade deflection measurements were obtained during the Smart Material Actuated Rotor Technology (SMART) test in the 40- by 80-Foot Wind Tunnel at NASA Ames Research Center (Fig. 1). This experiment measured deflections of a single rotor blade using two cameras acquiring image pairs in quadrant I (Ref. 3). The test provided the initial opportunity for BD system trouble shooting and testing and the operational experience needed to improve data acquisition and image processing techniques.

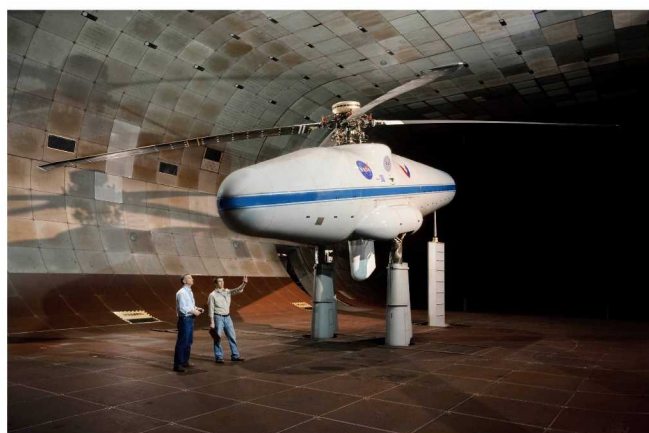
Figure 2. UH-60A installed on the LRTA in 40-ft by 80-foot test section of the NFAC.

The experiment discussed in the present paper is the second in the sequence of three rotor wind-tunnel tests that seek to provide a new benchmark for blade deflection data. The IBC test, conducted in the National Full-Scale Aerodynamic Complex (NFAC) 40- by 80-Foot Wind Tunnel is shown in Fig. 2. Blade deflection measurements were acquired for two rotor blades with four cameras acquiring sequences of image pairs spanning two rotor quadrants.

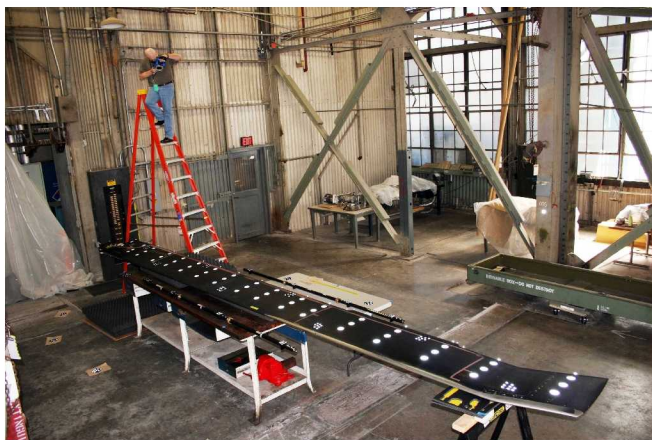
Figure 5. Blade with two-inch diameter retro reflective targets installed.

The lower surface of two rotor blades was prepared with fifty, 2-inch diameter, retro-reflective targets. The targets were cut from 3M Scotchlite 7610 high reflectance adhesive tape. Figure 5 shows a targeted rotor blade with a target spanwise spacing of approximately $0.05R$, and three targets per station distributed in the chordwise direction.
